# Model 600XL

Pressure Reducing Valve with Integral By-pass

(1/2", 3/4", 1", 1 1/4", 1 1/2" & 2")

## □ Installation □ Testing □ Maintenance Instructions

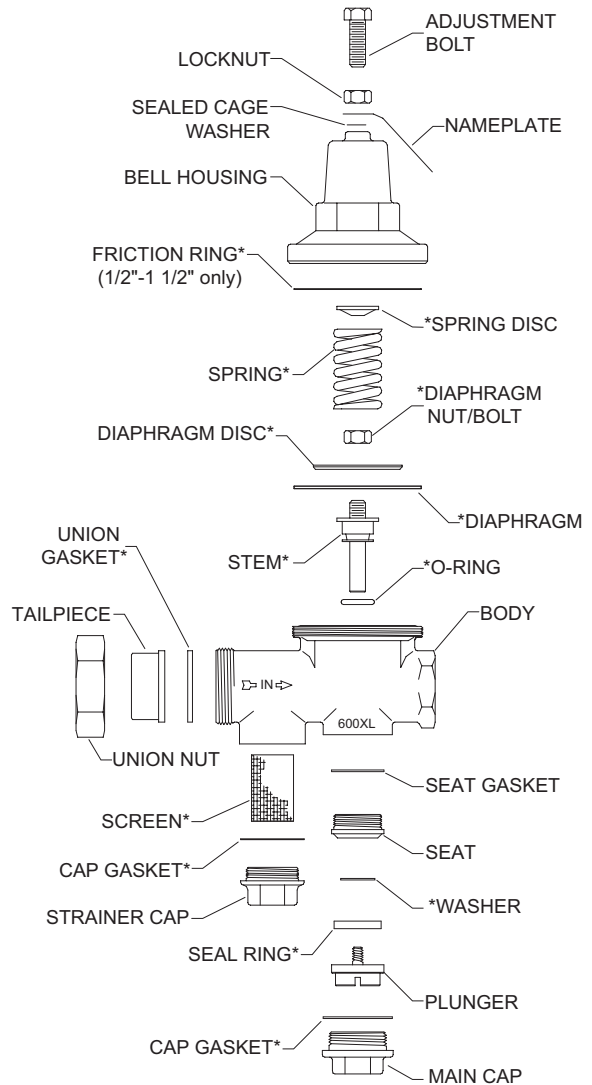
\* INDICATES PARTS SUPPLIED IN REPAIR KITS  
(spring disc not included in sizes 1 1/2"-2")

1. Open faucet on dwelling to remove line pressure.
2. Note distance that adjustment bolt protrudes from bell housing. Loosen locknut on adjustment bolt, then turn adjustment bolt out of bell housing until free of spring tension.
3. Loosen main cap and remove counterclockwise.
4. Loosen plunger and remove counterclockwise. Remove old seal ring then insert new seal ring.
5. Loosen strainer cap counterclockwise and remove screen.
6. Unscrew bell housing counterclockwise and remove spring, spring disc and friction ring.
7. Remove stem assembly from regulator. Inspect area in body where stem o-ring guides for pitting or scratches. Smooth bore with emery cloth if needed. This area must be smooth for the valve to function correctly.

1. Open shut-off valve slowly and flush body and line of any debris.
2. Assemble new stem unit using new stem, o-ring, diaphragm, diaphragm disc and diaphragm bolt/nut. Tighten bolt/nut securely (CAUTION: Be sure the rounded edge of the diaphragm disc is next to the diaphragm).

3. Lubricate o-ring with grease supplied in repair kit and install stem unit in body.
4. Center washer on stem. Screw plunger into stem unit. CAUTION: Do not over tighten plunger; it is possible to break the threaded end of the plunger.

5. Install new spring, spring disc and friction ring then replace bell housing by tightening clockwise. Turn adjustment bolt clockwise until adjustment bolt touches spring disc.

6. Install new screen, cap gaskets and replace caps by tightening clockwise.
7. Turn adjustment bolt into bell housing to old setting then enter dwelling and turn on several faucets.
